Case study #542

## STRENGTHENING DEEPWATER DRILLSHIP OPERATIONS

**Fortune 500 equipment provider gets turnkey support strengthening a critical riser component—and operator confidence.**

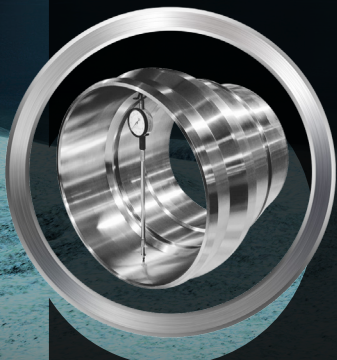
#### 945X Piston Actuator

High stress component in hydraulic riser running tool.

- Minimum Yield Strength of 150ksi
- Adherence to stringent NACE MR0175/ISO-15156-3
- Age hardenable nickel-iron-chromium alloy with molybdenum, copper, niobium, titanium and aluminum

The customer selected PCC Energy Group's INCOLOY® alloy 945X®—which would mitigate the catastrophic system effects of galling caused by component friction and adhesion. Nobody understands how to work with an alloy better than the company that created it, so the components were engineered, forged and machined with 100 percent confidence of project success. In fact, approximately 80 percent of all high-performance nickel alloys used upstream were invented by PCC Energy Group metallurgists.
